CALIFORNIA DIVISION OF MINES AND GEOLOGY

FAULT EVALUATION REPORT FER-101

November 5, 1980

Hayward fault (^{Richmond segment} north of University of California), and Wildcat fault of Bishop (1973).

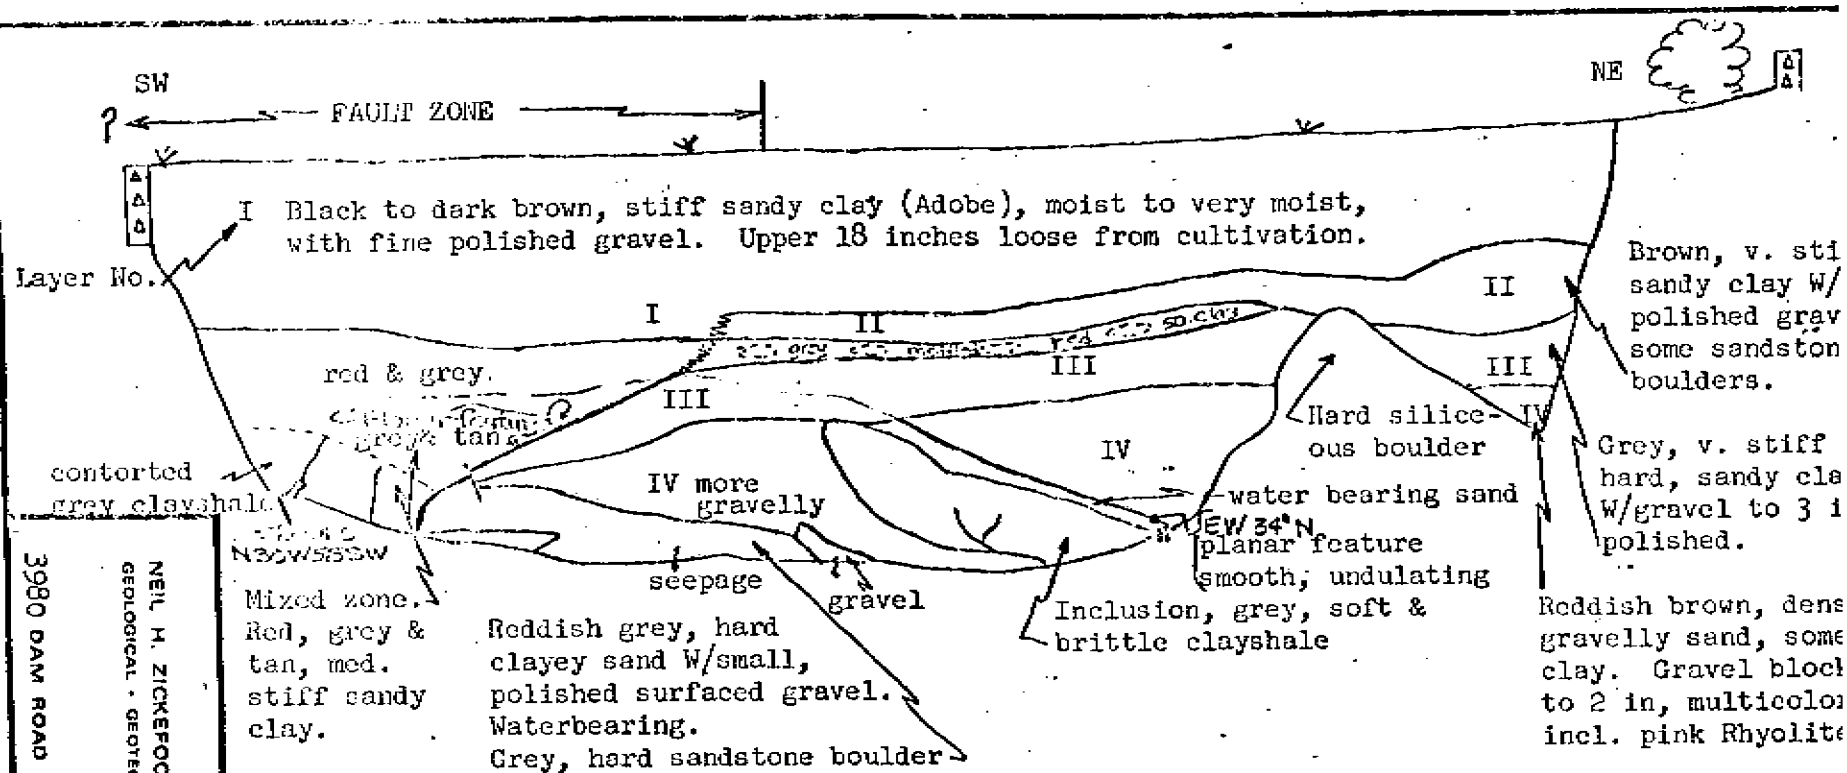
FER-101
Figure 4. Trench log from
Zickeroose & Assoc (1980).

Zickefoose and Associates (1980, map reference C377) detected^t what they determined to be a Holocene or historic fault in an area of recent landsliding. They could not, however, detect any through-going air photo lineaments on the site. The trench logs, reproduced here as Figures 4 and 5, document anomalous conditions along a Case (1963) fault.

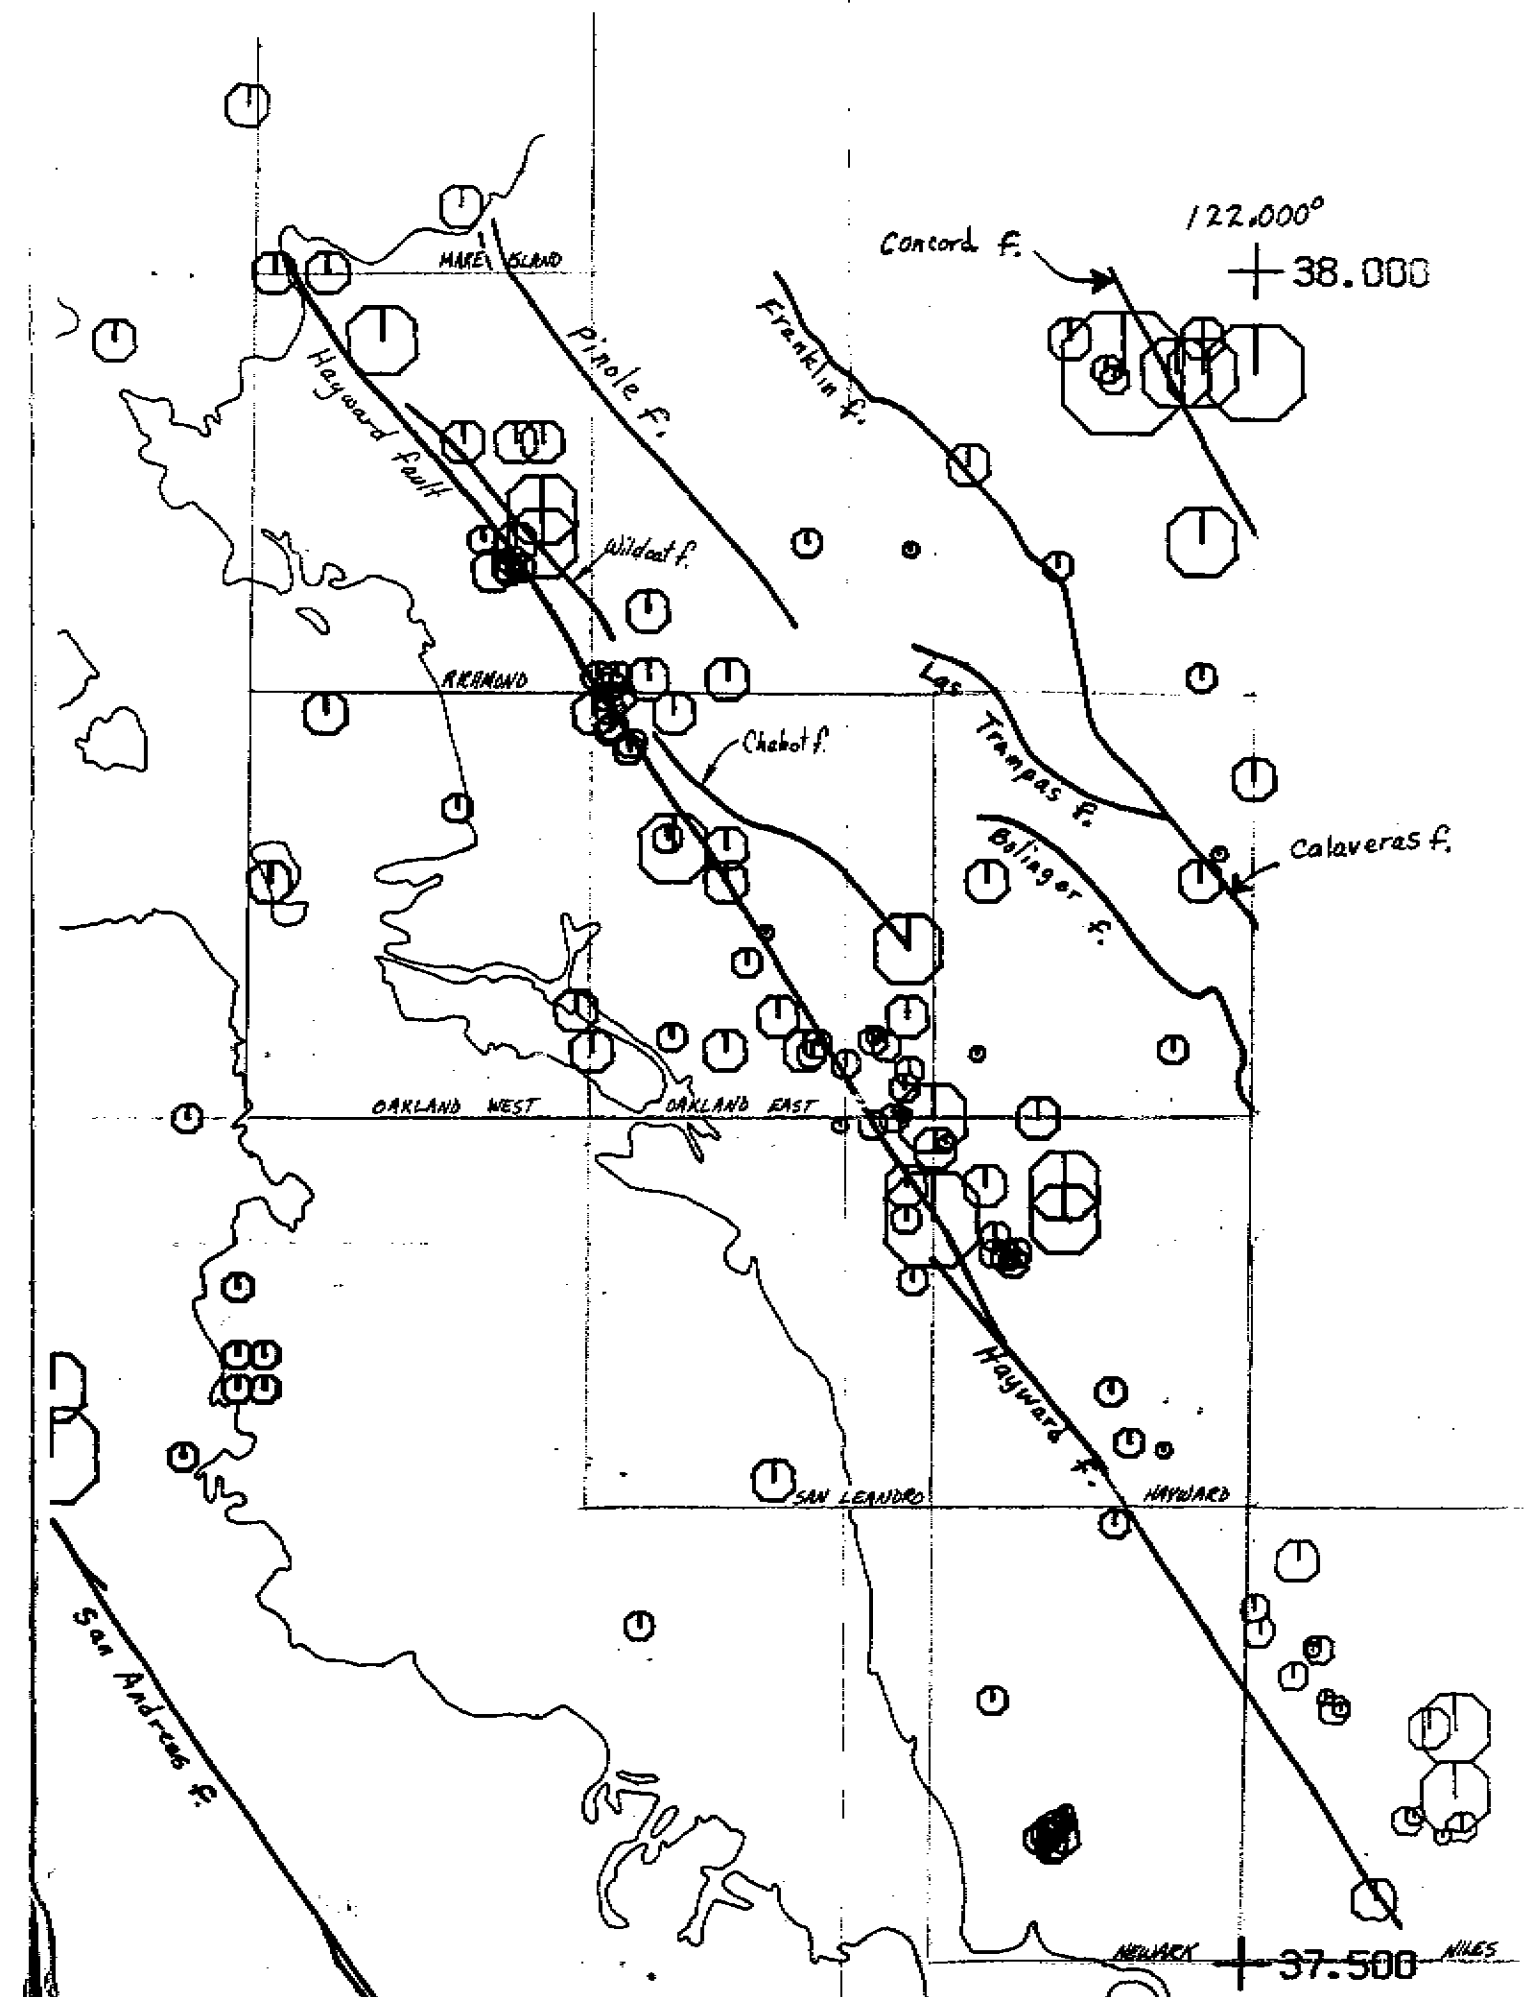
Figure 8. Locations of "A" quality earthquake epicenters in the vicinity of the Hayward fault from Point San Pablo to Niles (after Real, et al., 1978) and principal faults in the area.

The Hayward fault has long been documented as seismically active. As noted earlier, major earthquakes occurred in 1868 (Lawson, and others, 1980) and 1836 (Louderback, 1947). Real, et al. (1978, see Figure 7) have documented a zone of seismicity along the Hayward fault. Most of the epicenters are calculated to lie on or slightly east of the trace of the Hayward as shown on most maps.
